Manhole Inspection Summary

Manhole # S03WW1002MH

Insp Date: **8/16/06 12:00 AM**

Location Address: **6004 WALLIS AVE**

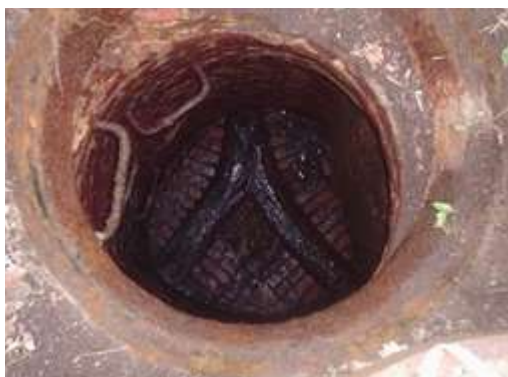
Top View

Corroded steps. Bench debris.

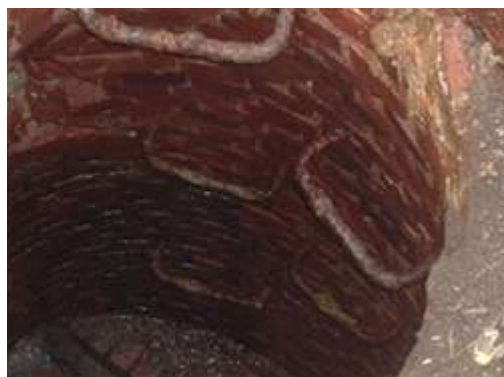
Defect

Adjustment, Corbel, and Barrel deterioration and infiltration. Corroded steps - other side.

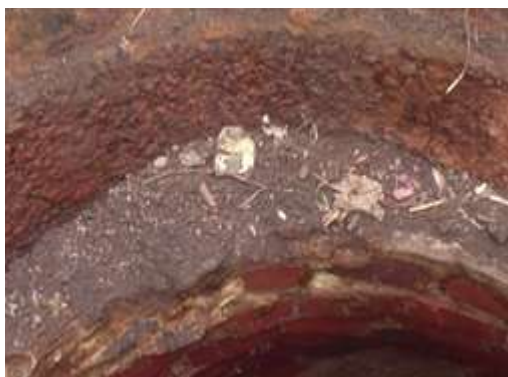
Defect

Frame offset. Adjustment infiltration.

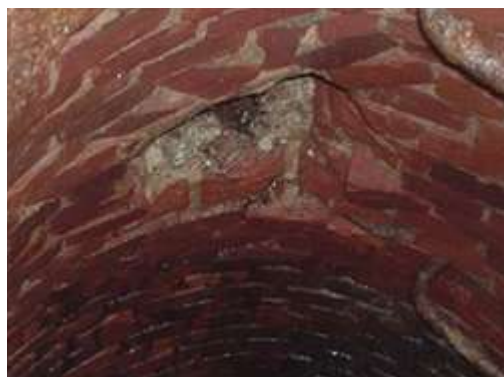
Defect

Corbel deterioration and infiltration. Barrel deterioration, root intrusion and infiltration.

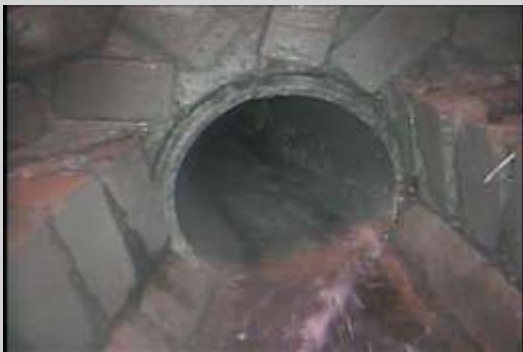
Pipe Out @ 12 O'Clock

Infiltration: **Evidence** Pipe Seal Cond: **Unknown**

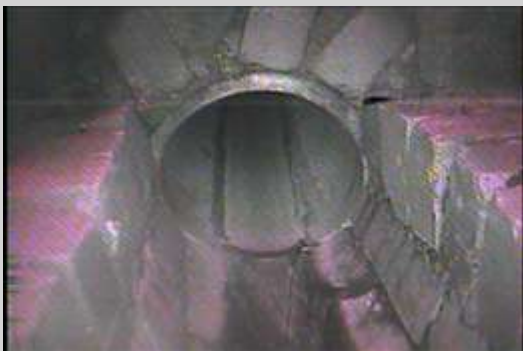
Pipe In @ 4 O'Clock

Infiltration: **Evidence** Pipe Seal Cond: **Cracked**

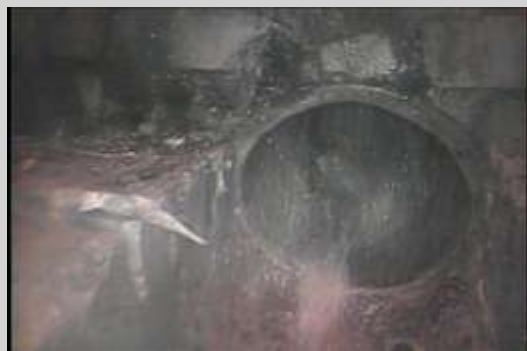
Pipe In @ 8 O'Clock

Infiltration: **Evidence** Pipe Seal Cond: **Cracked**

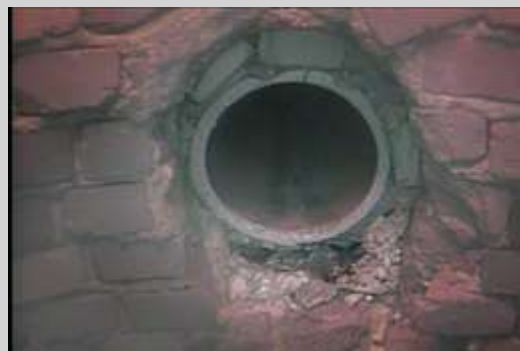
Drop In @ 8 O'Clock

Drop: Outside	Rod and Bar
Angled: Yes	Reading: 8.82 (ft.)
	Inv Depth: 9.82 (ft.)
Drop Condition: Open
